Naval Surface Warfare Center Carderock Division

NSWCCD-65-TR-2003/39 September 2003

SIDER Testing of Two Range Safety Craft

SUBJ: STRUCTURAL IRREGULARITY AND DAMAGE EVALUATION ROUTINE
(SIDER) INSPECTION OF SHIP STRUCTURES

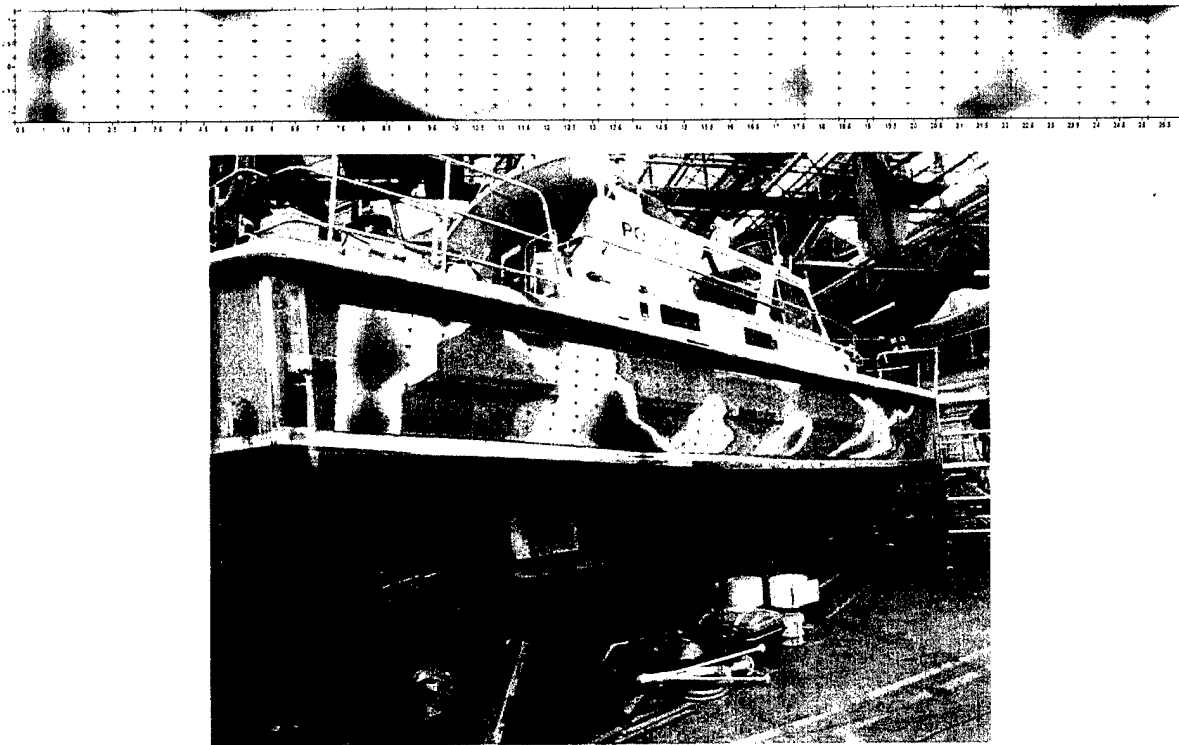
Figure 9. SIDER Results for Test ID R1

The two results show a remarkable agreement in both pattern of features and magnitude of SIDER values. Both tests identify the same basic regions as “clear” of irregularity. The main difference seems to be that the features identified by the small hammer are slightly larger in both magnitude and area.

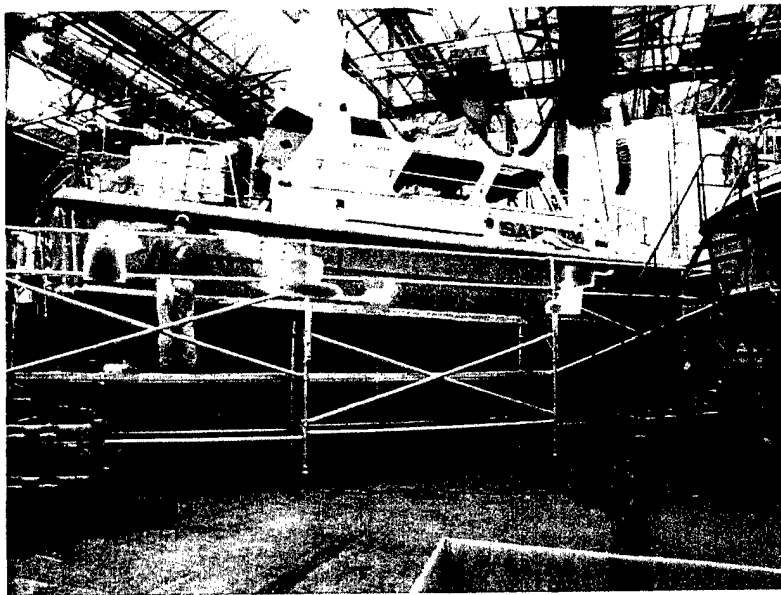
Figure 11. SIDER Results for Test ID R3

The two RSCs are sister vessels. There are, though, some differences. RSC Police had its starboard engine installed, whereas RSC 8126 had no engines in place. Also, there were some differences in internal attachments to the hull, and the hull penetration layouts were different. Despite these differences, the SIDER inspections have produced very similar plots of structural irregularity features. This result suggest that a baseline SIDER from one vessel may be useful in identifying problems with another hull.

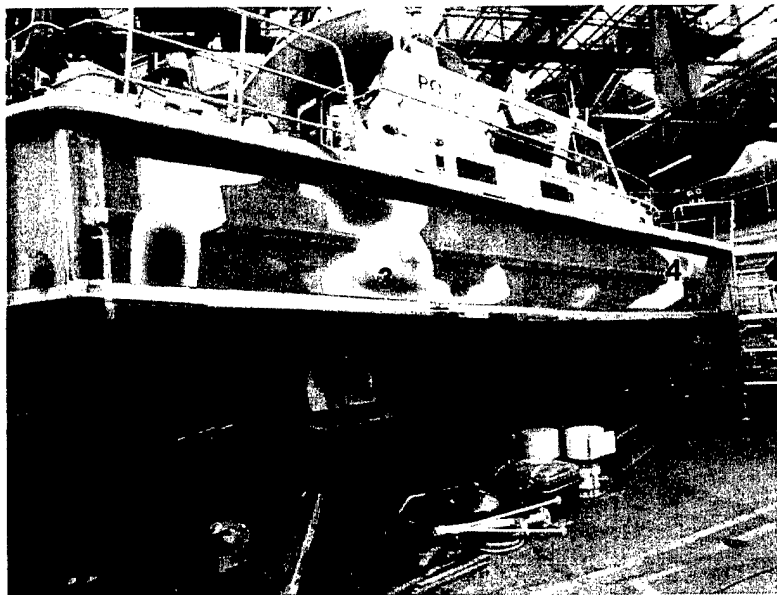
Figure 12. SIDER Results for Test ID R2 with Marked Features

Feature 1 is coincident with an internal bulkhead. Examination of this part of the RSC Police hull by Keith Vernon, Senior Surveyor, Lloyd's Registry of London, confirmed that this SIDER feature had identified damage (probably delamination or debonding) between the main hull shell and the bulkhead. This is a high-risk part of the vessel, since it often gets hit during alongside maneuvers. There was also some nearby cracking of the internal bulkhead, but this

was not in the area that had been SIDER inspected. Mr. Vernon did note, though, that the identification of this crack was significantly aided by knowledge of the damage location identified by the SIDER analysis.

Feature 2 is strong on RSC Police, but minimal on RSC 8126. Internally to RSC Police, there is a wiring support harness at this location. It does not exist in the RSC 8126. It is speculated that SIDER has located the wiring harness, but it is possible that there is other hidden structural irregularity. The wiring harness is shown in Figure 13.

Feature 3 shows on the results for both craft. There were no obvious problems or structural features at this location, but since the feature is apparent on both RSC results, it presumably maps to some structural or damage-related stiffness variation. The thick noise and vibration lagging on the inside surface of the hull precluded a detailed investigation of this area.

Feature 4 also shows on the results for both craft. At this point inside the hull there is a small galley, and it was not possible to get to the inside surface of the hull shell. However, this is another high-risk part of the hull, prone to impact damage during alongside evolutions.
